APPENDIX A
SITE PHOTOGRAPHS

PHOTO POINTS – REACH #1

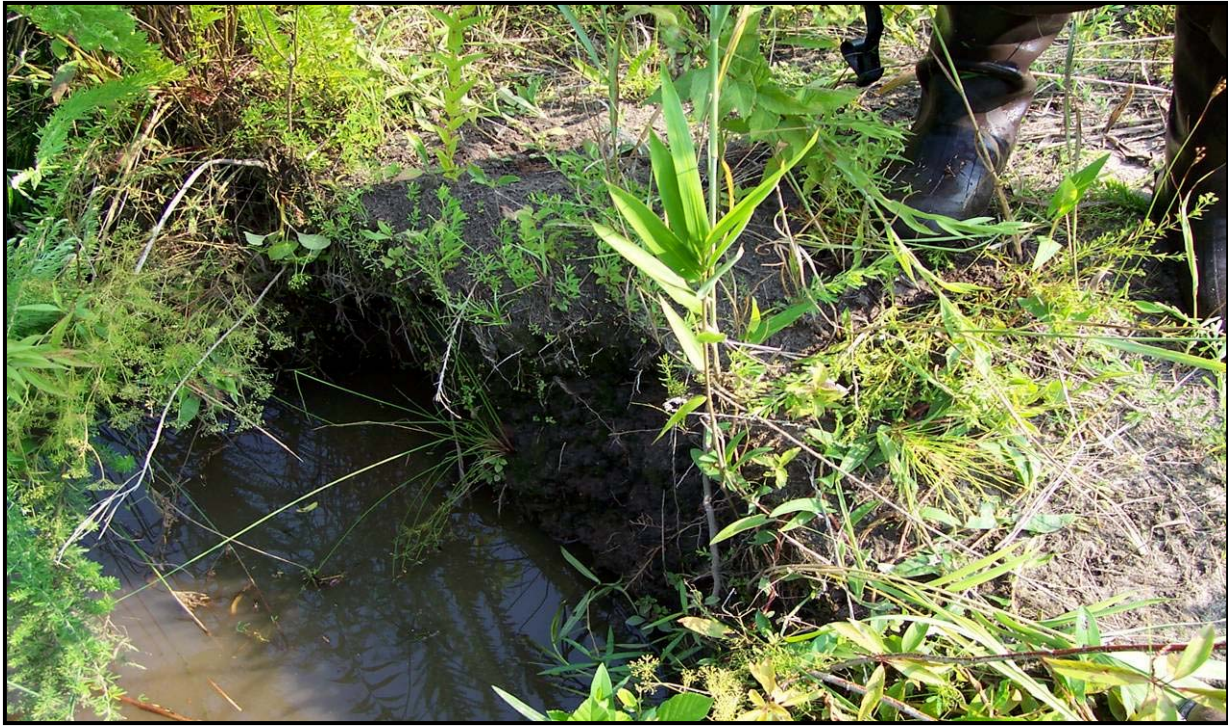
Localized bank scour along Reach #2 at Station 5+18 – Year 2005
